In accordance with our approved October 21, 2014 scope of services document, the Whitman, Requardt & Associates, LLP (WRA) team has prepared this Design Level Inspection Report to present our findings (with repair recommendations and conceptual costs) resulting from the recently completed design level inspection and testing of the specified project bridges, which include the following:

The Wilmington Viaduct consists of Bridges 1-748, 1-748N, and 1-748S and comprises the mainline elevated section of I-95 in downtown Wilmington, Delaware over Amtrak and various City streets. The entire structure is a sixty (60) span steel beam bridge composed entirely of single span units built in 1964 and widened in 1978. Rehabilitation was performed on the viaduct in 2000 that included bearing replacements, seismic retrofits, strip seal replacements, parapet rehabilitation, substructure repairs, drainage repairs, and painting. The viaduct has an overall length of 5462'-0"± measured from centerline of abutment bearings.

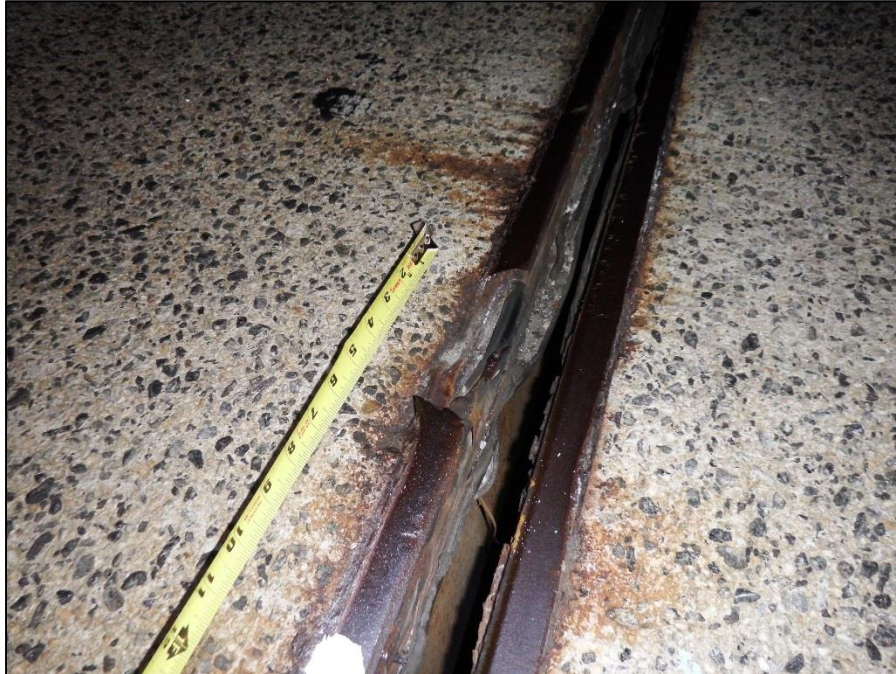
Photo 1: Torn joint seal and corroded armoring (Span 7 Northbound, Pier 6)

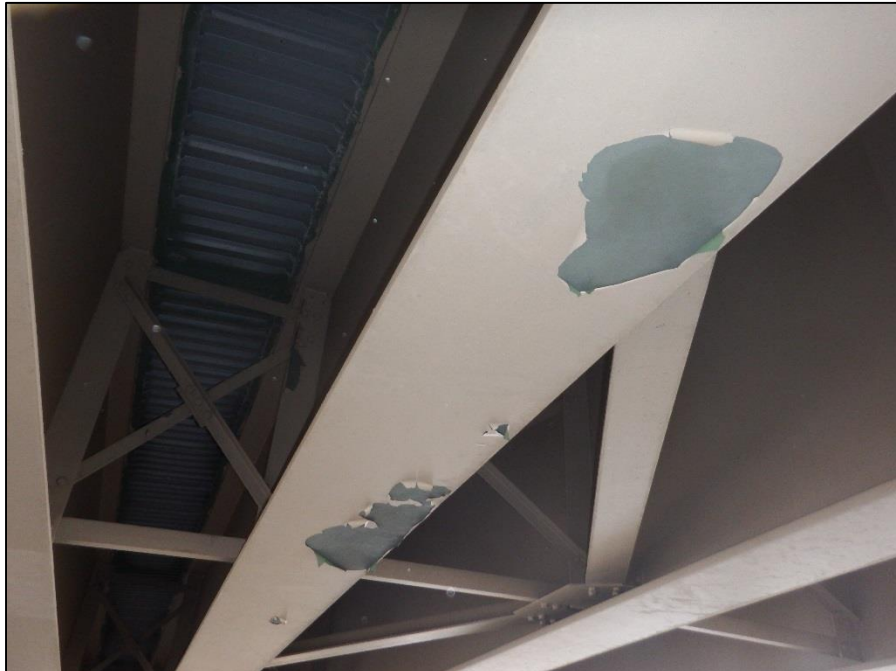
The beams and girders exhibit random areas of freckled corrosion throughout, random locations of peeling and flaking paint (see Photo 4), and the ends of the beams and girders exhibit minor to severe corrosion. The webs and bearing stiffeners typically exhibit up to 1/4" painted over pitting (see Photo 5). Span 25, Girder 17 at Pier 24 exhibits severe section loss to the web and up to 100% section loss of the bearing stiffeners (see Photo 6). Steel diaphragms exhibit minor to severe corrosion at the piers, and random areas of peeling paint with exposed primer on the bottom flanges throughout. The bearings that are not greased typically exhibit minor corrosion to the plate edges, 1/2" rust laminations, 1/4" pack rust between plates, and up to 1/4" pack rust between masonry plates and pedestals (see Photos 9-13). The expansion bearings for BR 1-748N and 1-748S from Spans 47 through 60 exhibit abnormal movement with locations of over contraction/expansion (see Photo 14). Anchor bolts typically exhibit up to 20% section loss. Previous seismic retrofits have put anchor bolt nuts in contact with keeper plates which has the potential to restrict proper movement.

Photo 4: Typical peeling paint with exposed primer (Span 23, Beam 9)

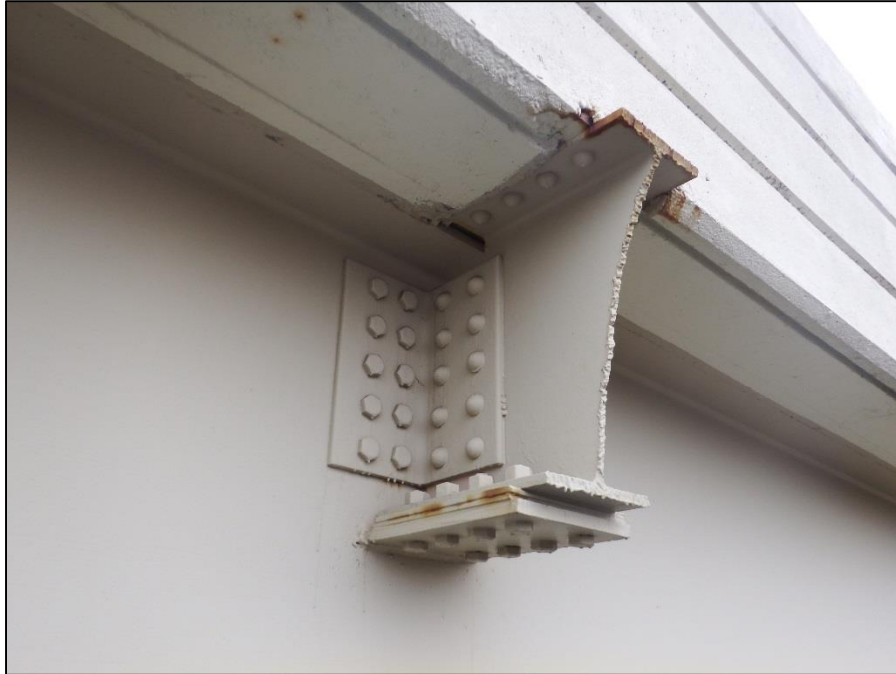
Photo 7: Previous sign structure support to be removed (Span 35N, Beam 6)

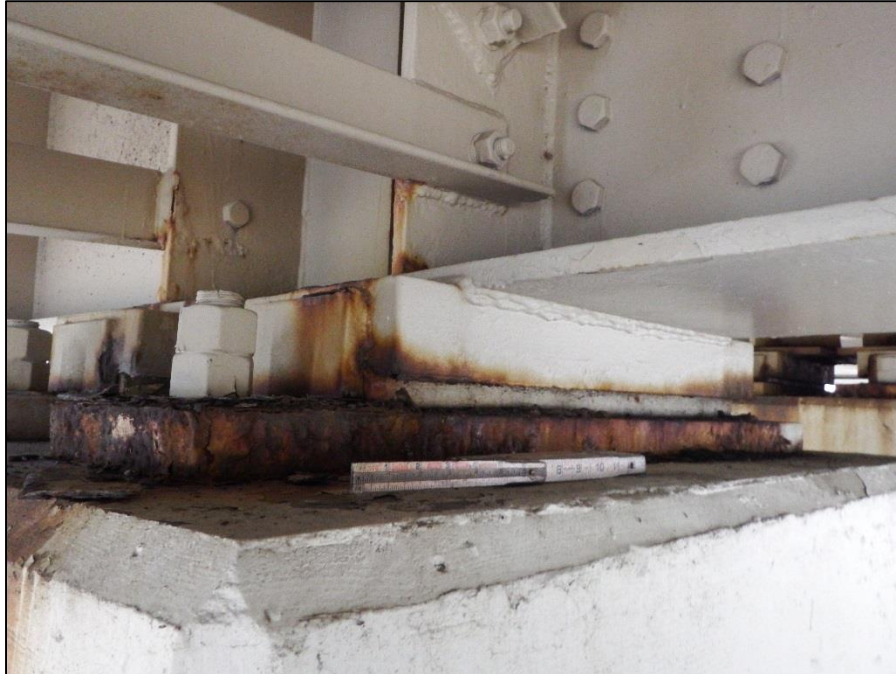
Photo 9: Typical bearing corrosion (Span 9, Pier 8, Bearing 15)

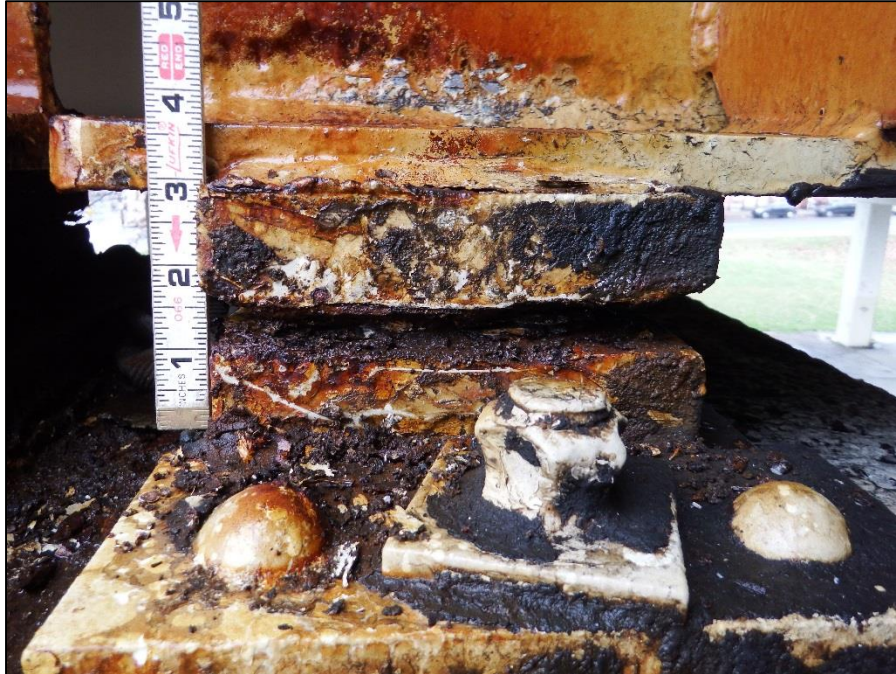
Photo 11: Painted over section loss to anchor bolt nut (Span 52N, Bearing 6)

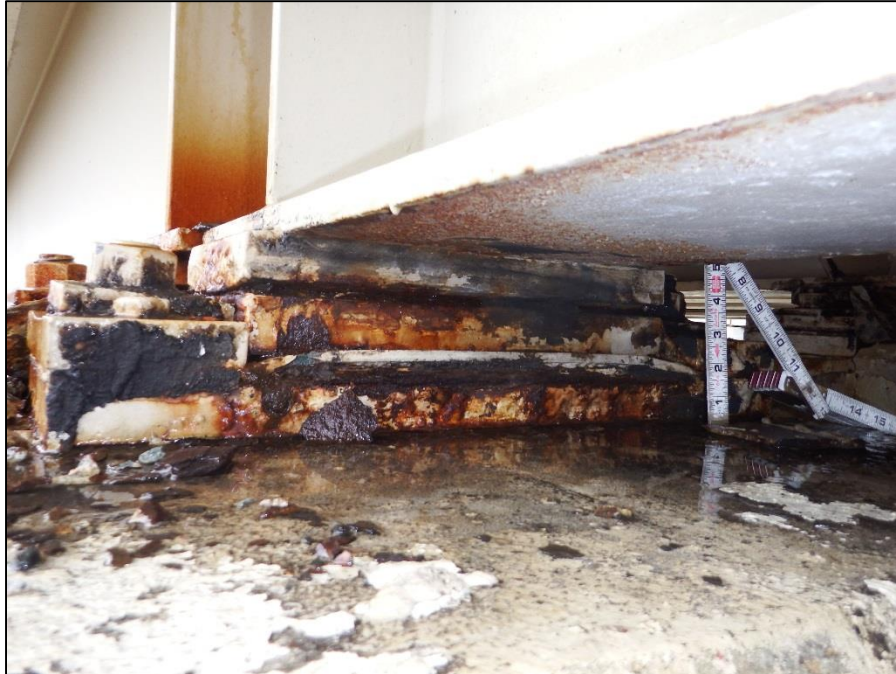
Photo 13: Pack rust between masonry plate and shim plate preventing contraction (Span 54N, Bearing 9 at Pier 53N)

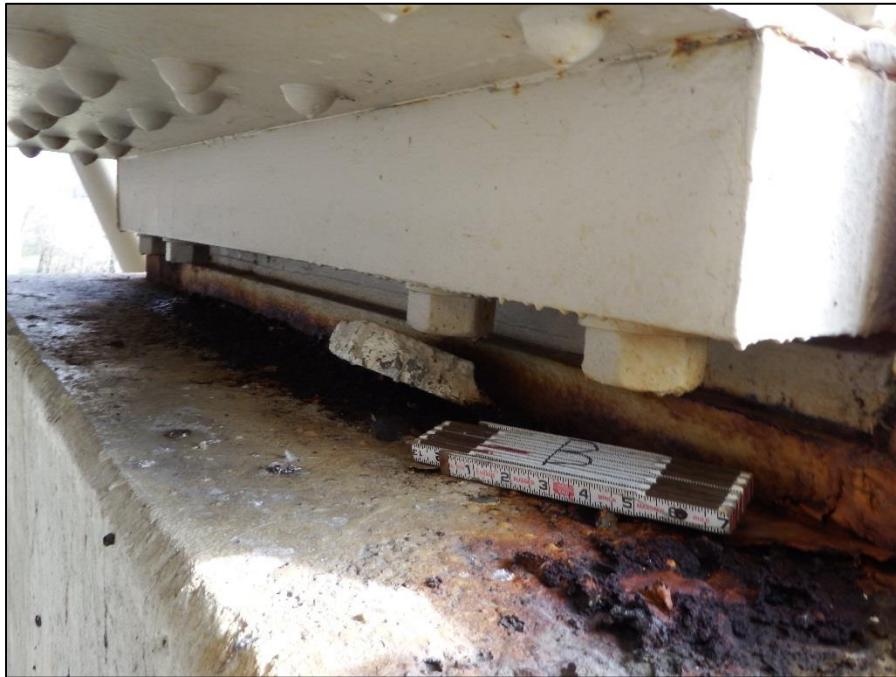
Photo 20: Steel debris (Span 11, Pier Cap 11, Bearing 3)

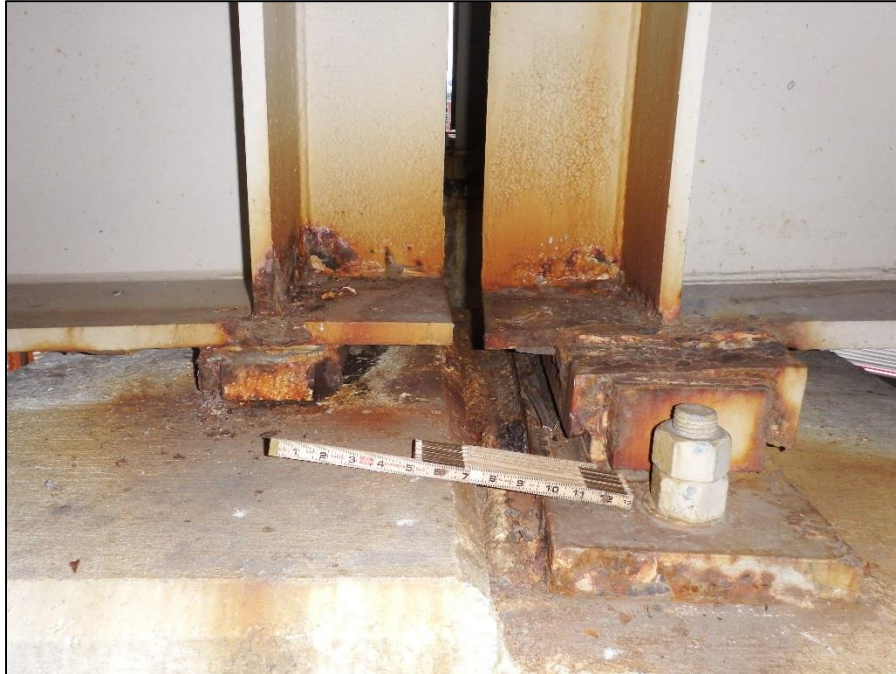
Photo 3: Corrosion and pitting at ends of girders (Spans 2 & 3, Girder 1)

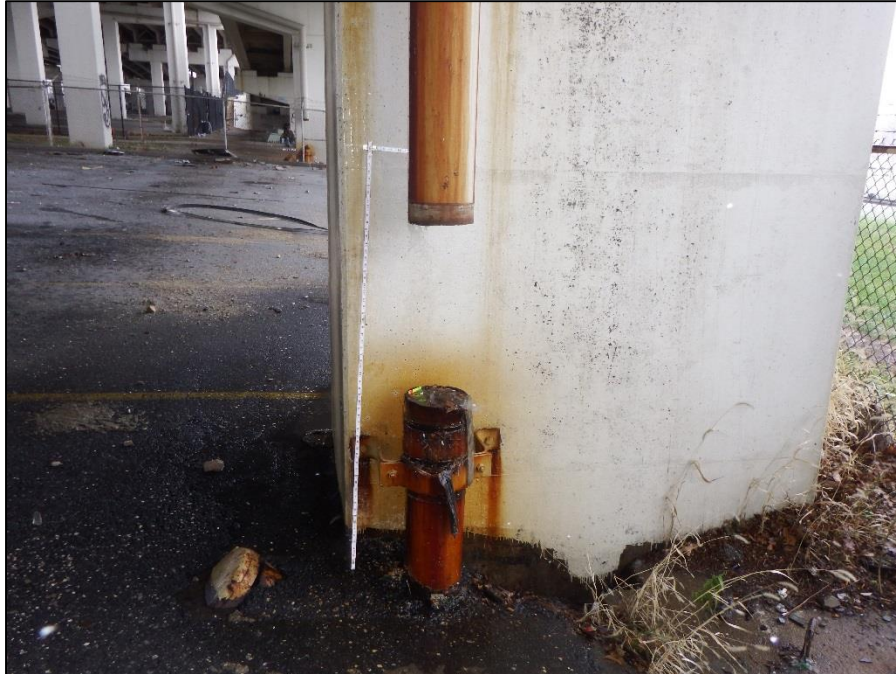
Photo 7: Disconnected and clogged downspout (Pier 3, South Face)

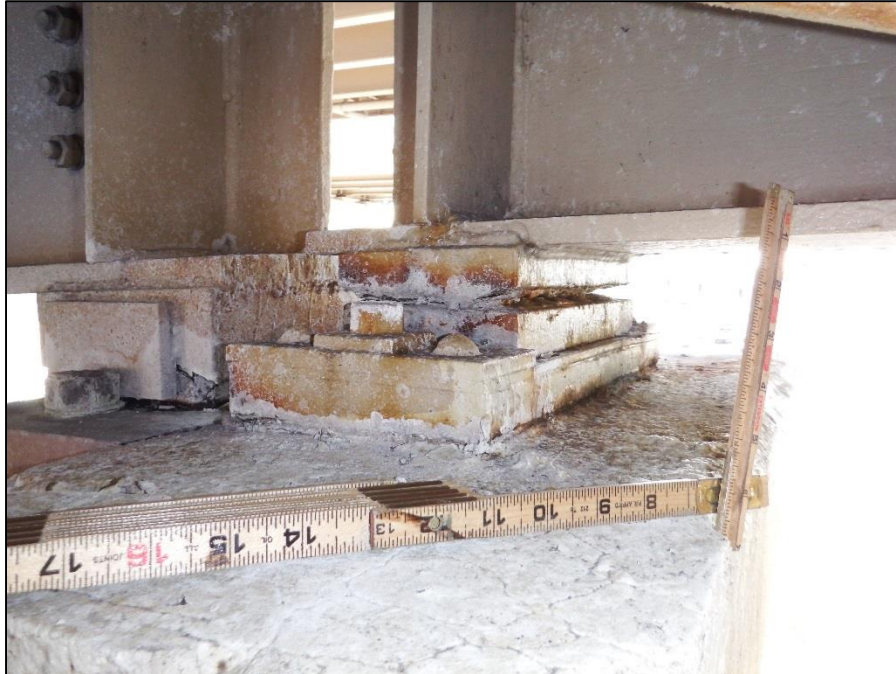
Photo 1: Pack rust between plates (Bearing 1, Span 1 at Pier 1)

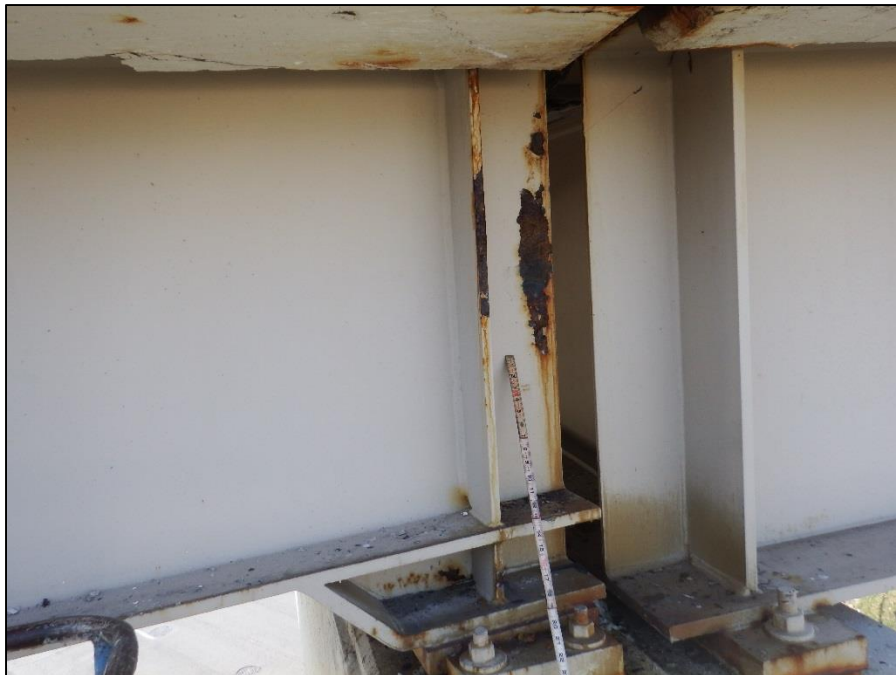
Photo 2: Typical 1/8" pitting (Span 3, Beam 4 at Pier 9)

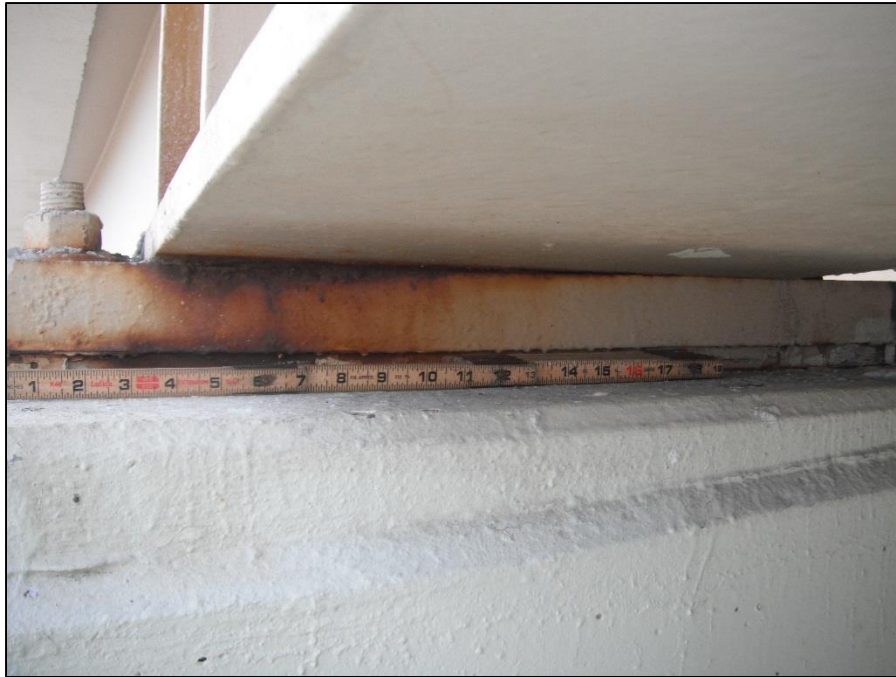
Photo 3: 1/8" gap between bottom flange and sole plate (Span 5, Beam 4 at Pier 8)

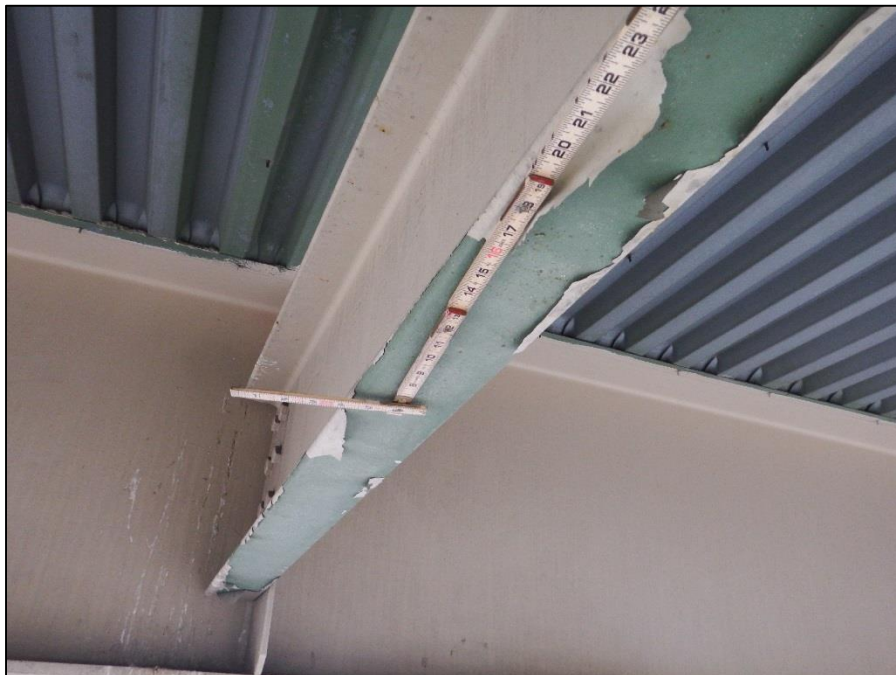
Photo 2: Typical interior diaphragm peeling paint (Span 4, Bay 4, Diaphragm 2)

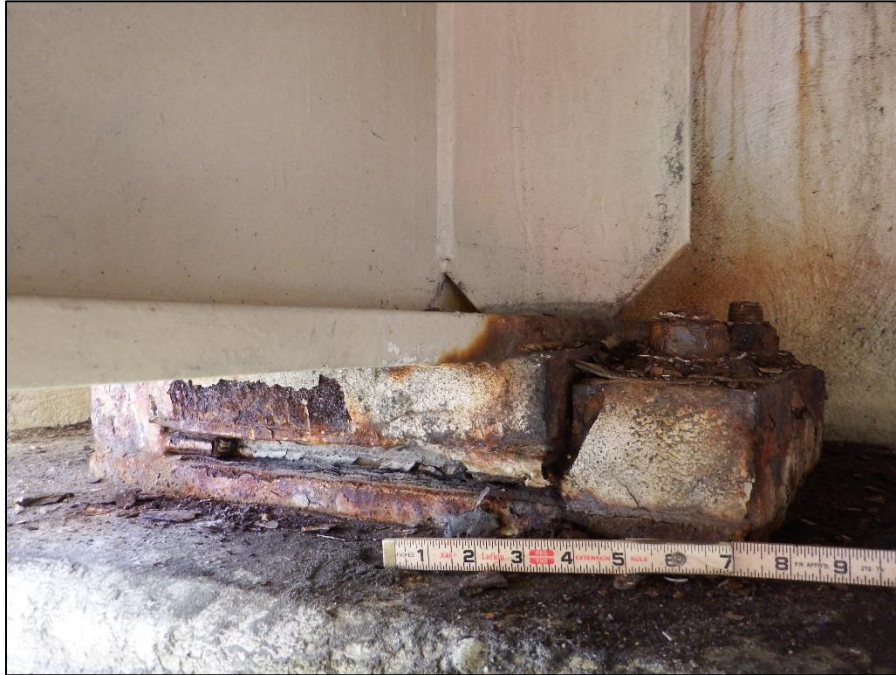
Photo 3: Typical bearing corrosion, rust delaminations (Span 1, Bearing 4 at West Abutment)

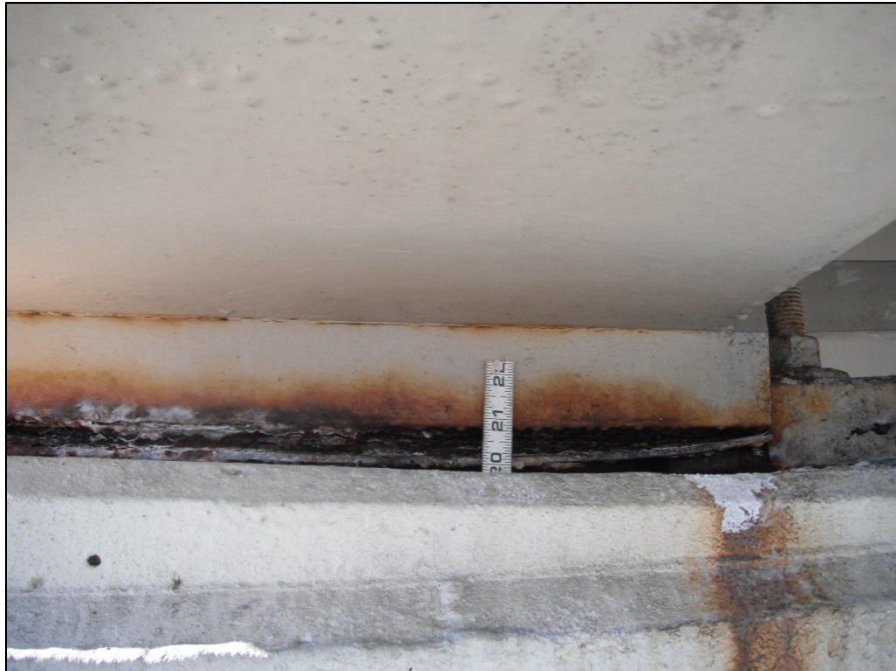
Photo 4: Pack rust between masonry and shim plate preventing movement (Span 2, Bearing 1 at Pier 1)

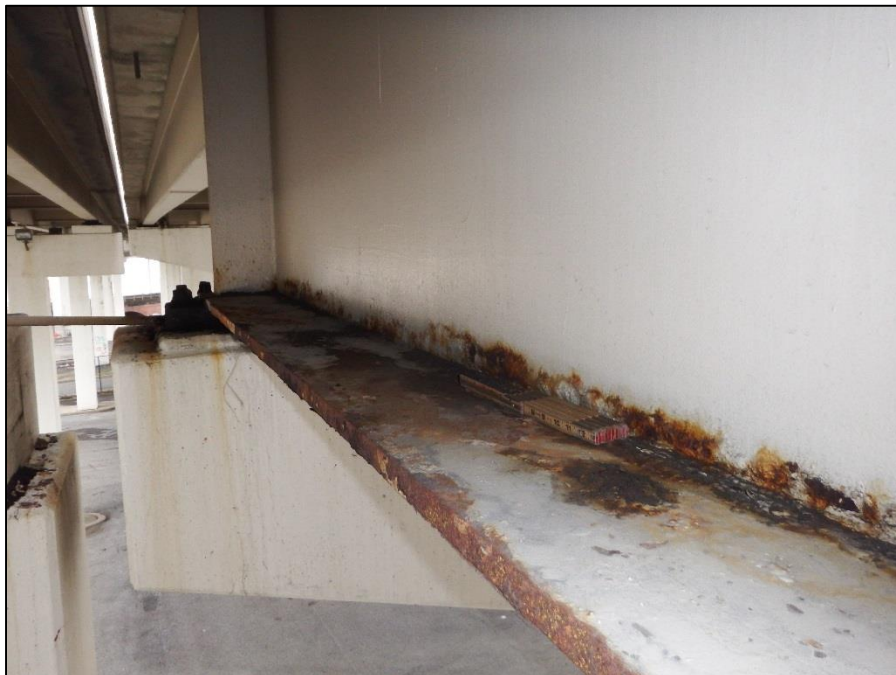
Photo 2: Typical beam end corrosion and pitting (Span 7, Beam 4 at Pier 6)

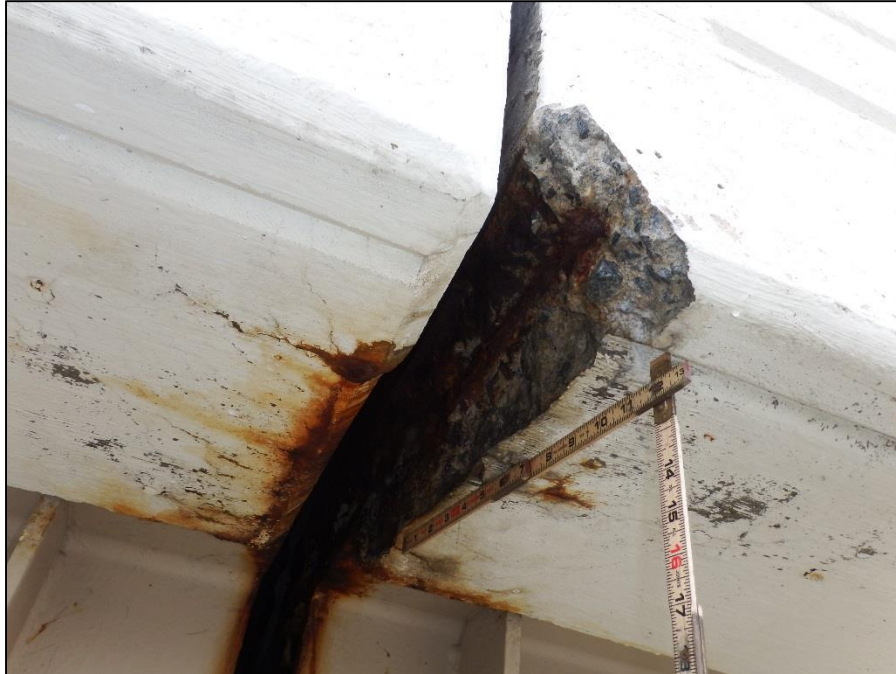
Photo 1: Spall in soffit at joint with exposed corroded steel (Span 4, North Overhang at Pier 5)

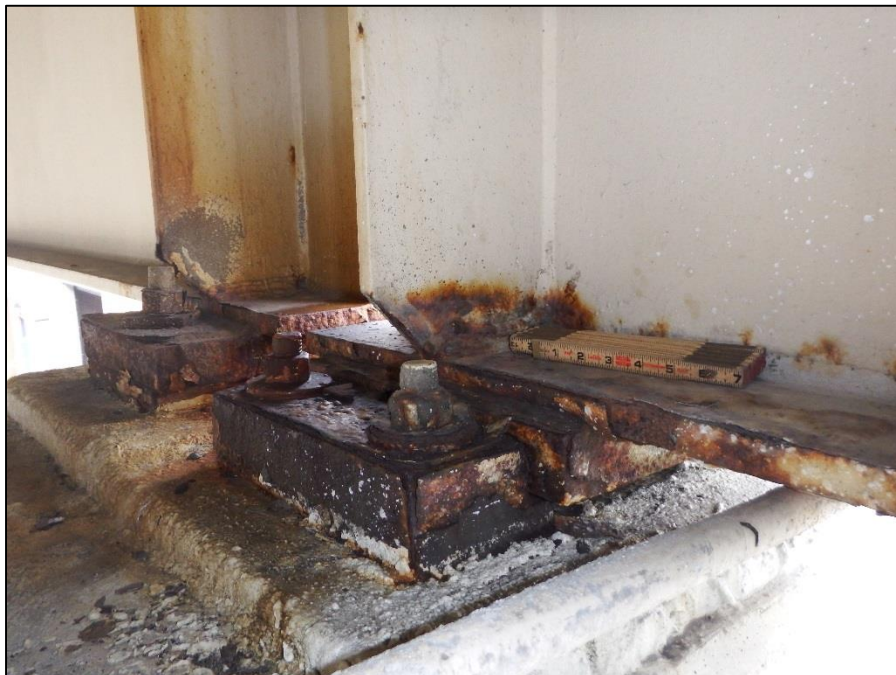
Photo 2: Typical beam end and bearing corrosion (Spans 5 and 6, Beam 1 at Pier 5)

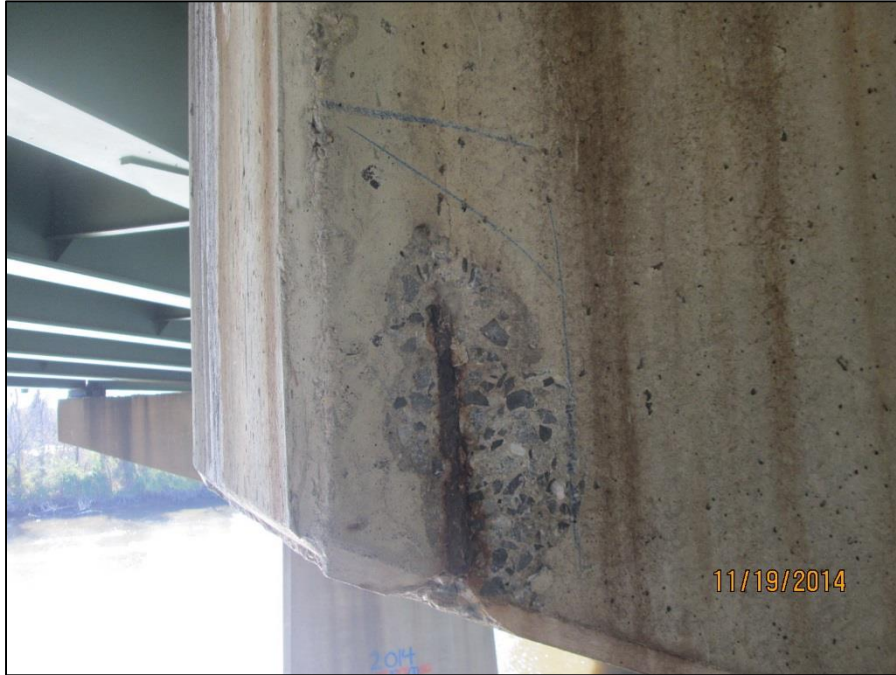
Photo 3: Typical Spall (North Face, Pier 5, East Overhang, Center pier)

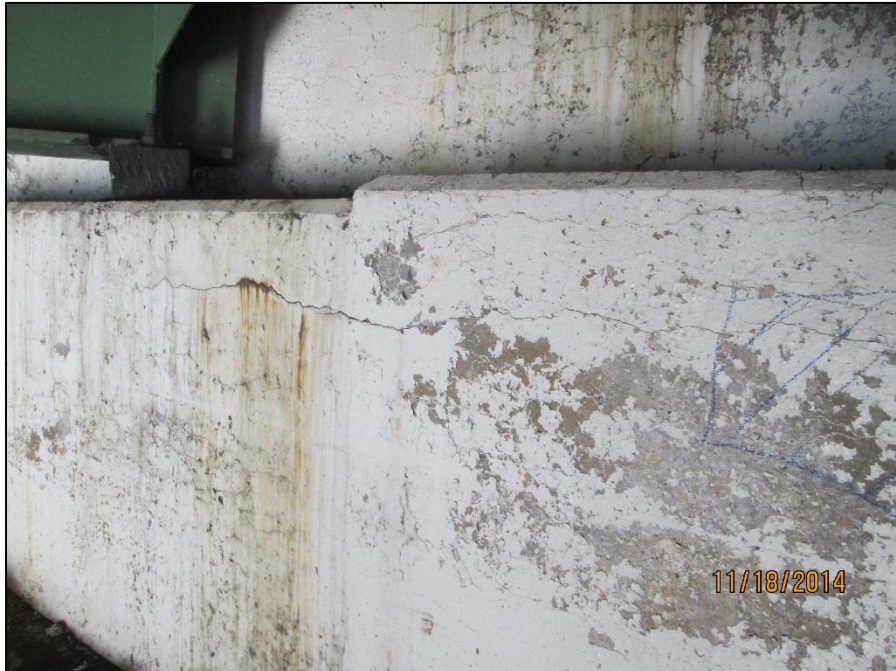
Photo 4: Typical horizontal 1/16" wide crack (North Abutment stem, Bay 5 shown)

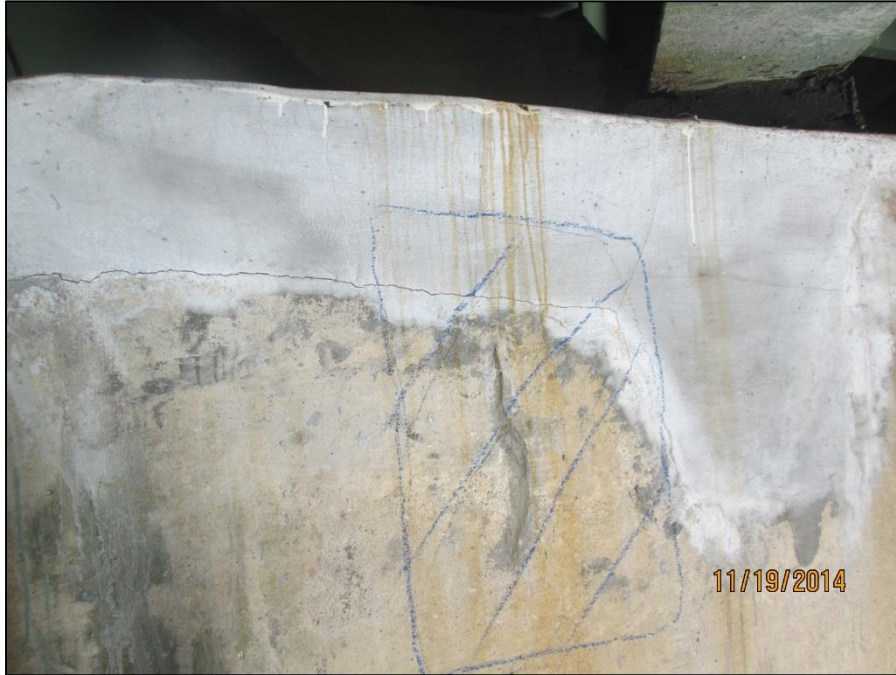
Photo 5: Typical area of delaminated concrete (Pier 6, west pier, south face, Bay 1 shown)

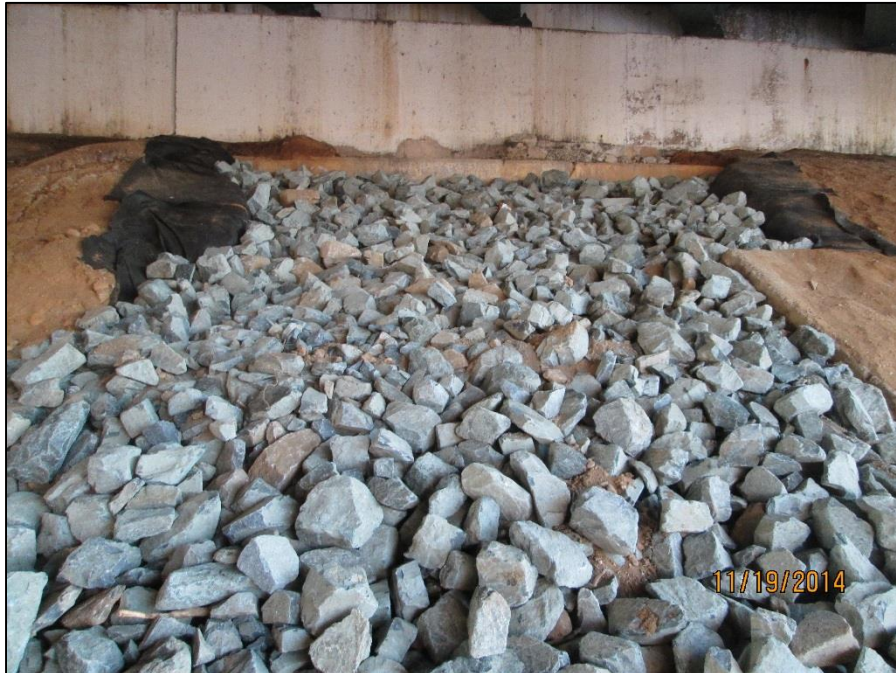
Photo 6: Exposed footing at the South Abutment

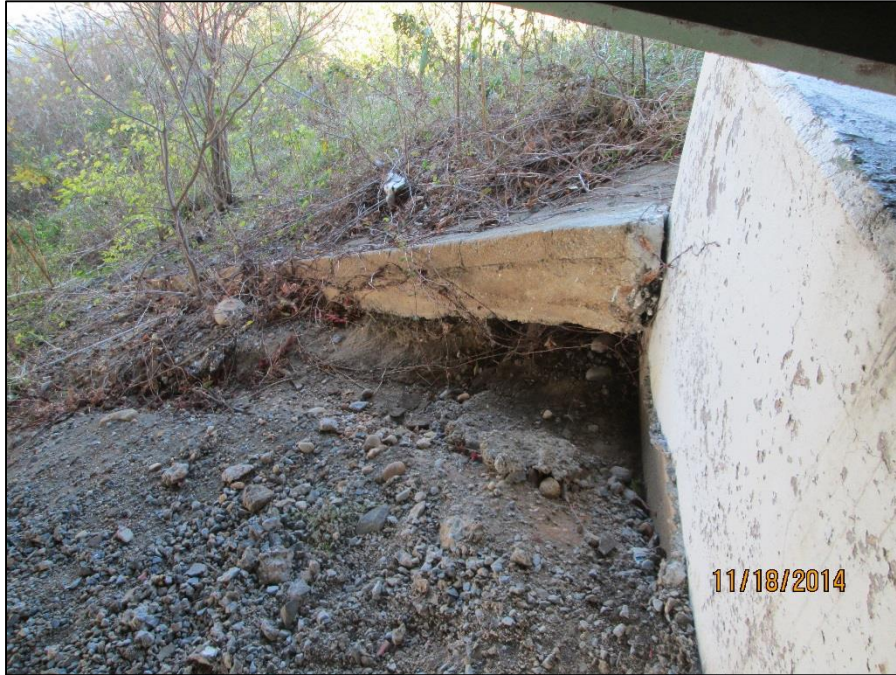
The deck joints exhibit signs of leakage. The painted steel beams exhibit localized areas of freckled rust and peeling paint mainly at the beam ends with some areas of exposed and rusted steel (see Photo 1). Several bearings have sheared or bent anchor bolts (see Photo 2). The reinforced concrete piers and abutments typically have cracking, spalls, and areas of delaminated concrete (see Photos 3, 4, and 5). There is a cable wrapped around the Pier 2 West column. There is a section of missing riprap exposing a portion of the footing at the south abutment (see Photo 6). There is erosion and adjacent undermining of the concrete slope protection at the north abutment (see Photo 7).

Photo 7: Erosion at the North Abutment slope

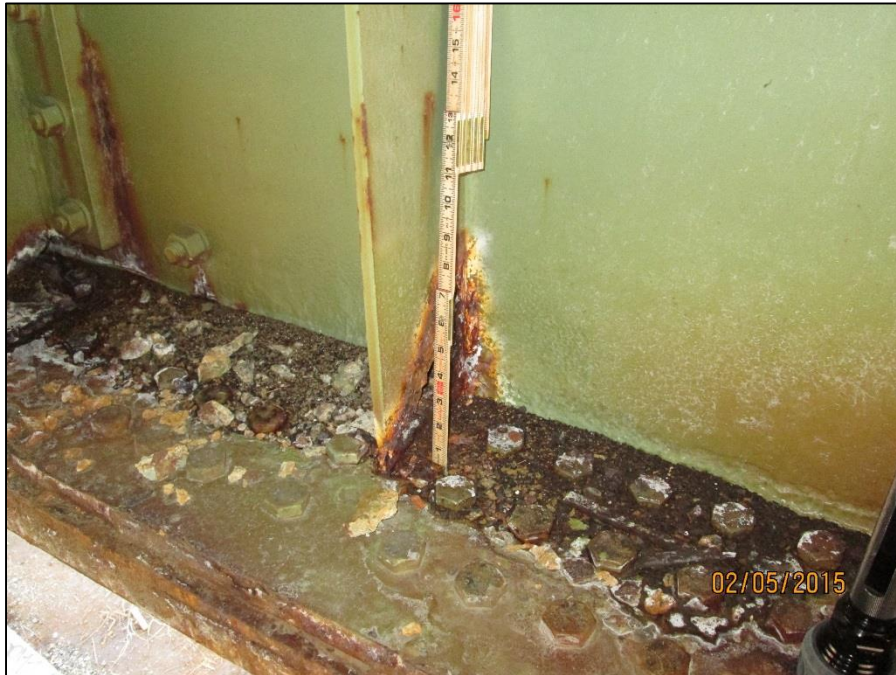
Photo 1: Section loss in the bottom of the stiffener, Pier 2 Cap, South Face, Between Beams 8 and 9

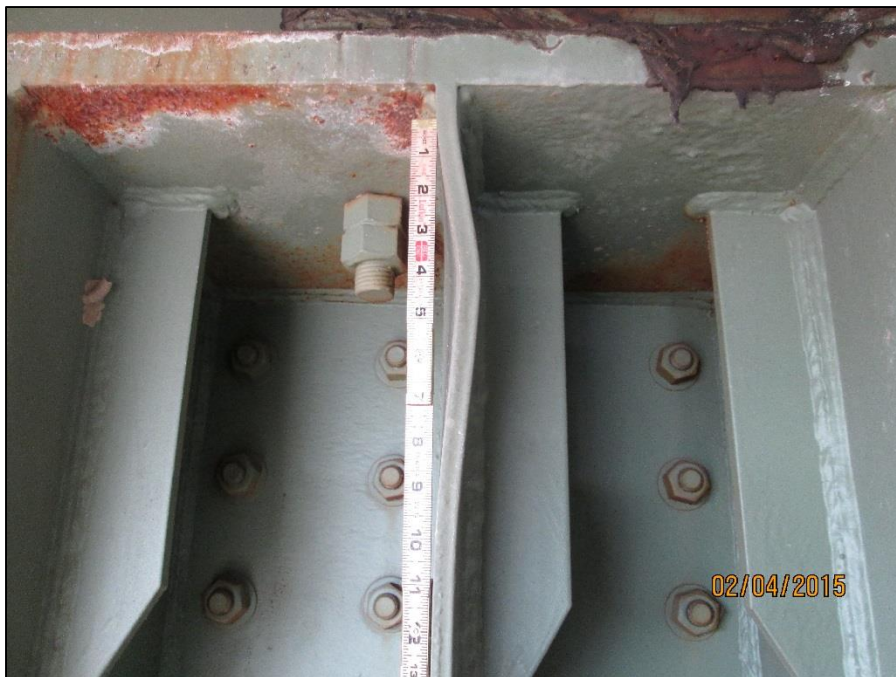
Photo 2: Bent stiffener at Pier 4, Span 4, Bearing 2 Seat

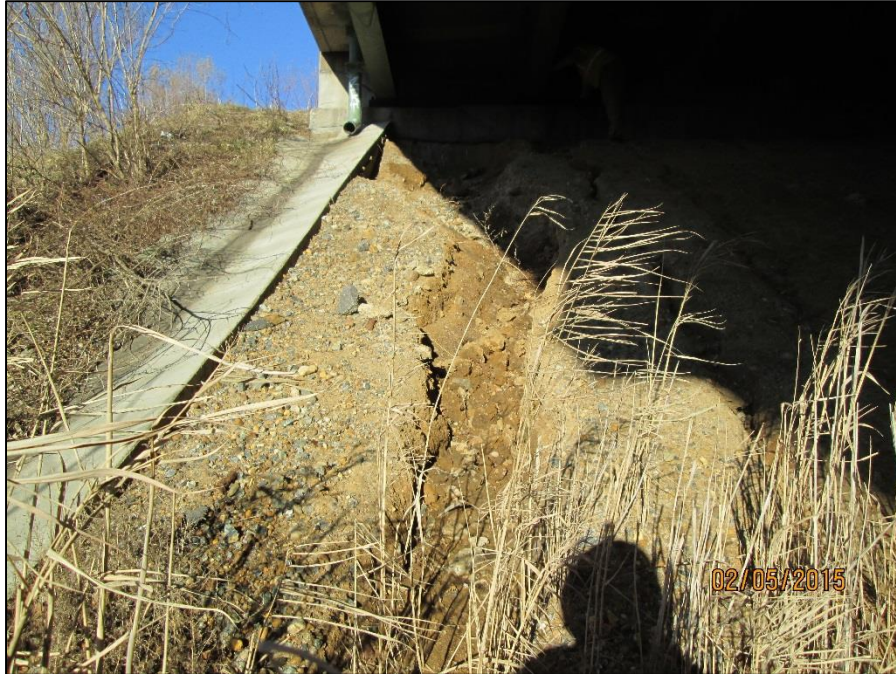
Photo 10: North Abutment Slope Erosion, East end

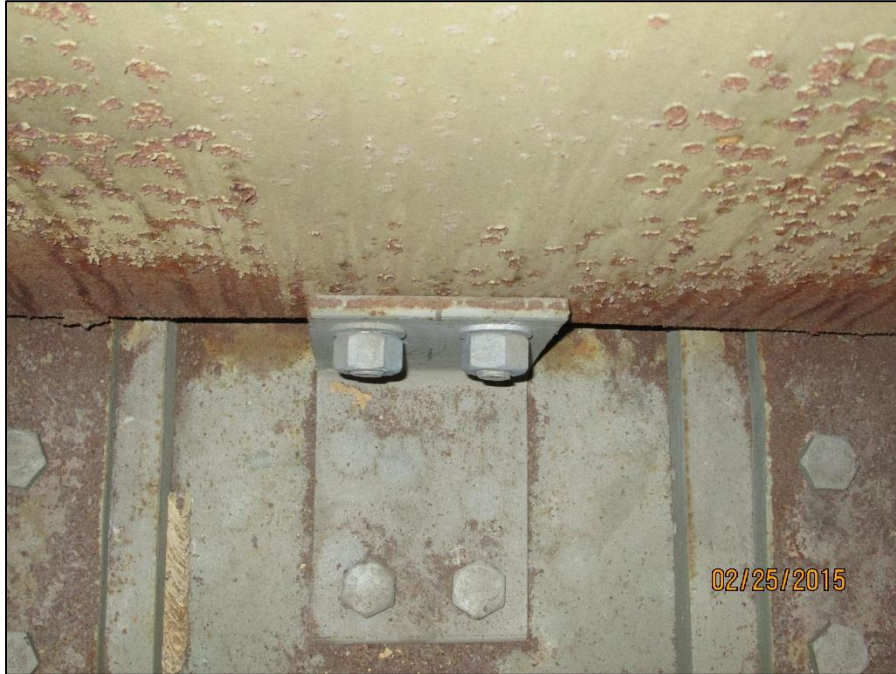
Photo 12: Two (2) loose bolts, East full height diaphragm, Pier 1 Cap, Bay 10

P-4-3	Pier 4, Column 1, South Face	Disconnected and clogged drain pipe (see Photo 7).
P-4-4	Pier 4 Cap, West Overhang	Broken access gate.
P-4-5	Pier 4 Cap, Bay 13	2'-9" long missing vertical weld extending from top continuing 2'-3" at the south edge of the east full height diaphragm (see Photo 12).
P-4-6	Pier 4 Cap, Bay 13	9" long missing vertical weld on the east face of the east half height diaphragm at south edge (see Photo 12).
P-4-7	Pier 4, Column 1, South Face	2'-0" wide x 2'-6" long x 1" deep spall.
P-4-8	Pier 4, Column 1, South Face	Up to 15'-0" long x 1/16" wide vertical crack.
P-4-9	Pier 4, Column 1, Northeast Corner	1'-0" wide x 2'-0" high area of delaminated concrete in a previous repair.
P-4-10	Pier 4, Column 2, East Face	6" wide x 1'-0" long area of delaminated concrete with a 2" deep spall with exposed corroded reinforcement.
P-4-11	Pier 4, Column 2, North Face	3'-0" wide x 2'-0" long area of delaminated concrete.

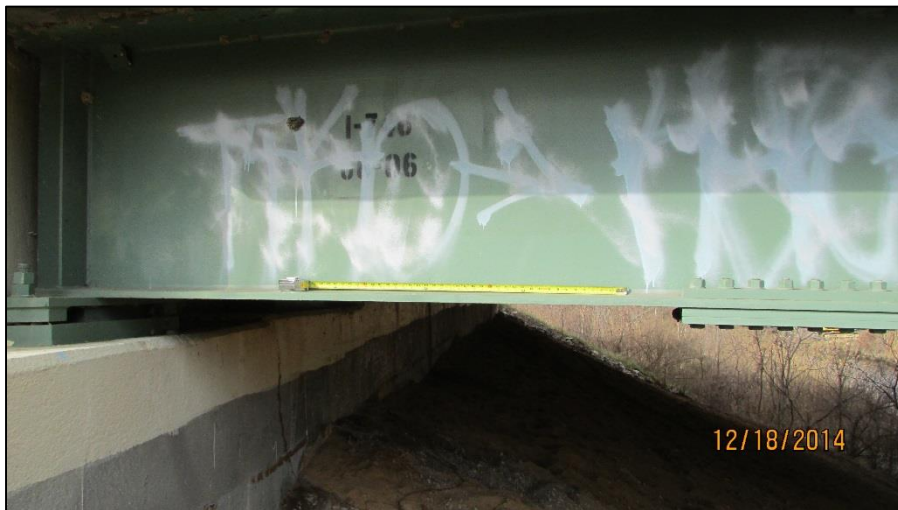
The superstructure exhibits small areas of paint blistering and chalking at the beam ends and on the bearings. At Span 1, Pier 1, Bay 4, there is an area of pack rust on the end diaphragm where the joint failed and water began leaking through. There are bird nests and insect hives throughout the underside of the superstructure (see Photo 5). There are also some isolated areas of graffiti at the beam ends near the abutments (see Photo 6). Approximately 30% of the bearing anchor nuts are not fully engaged.

Photo 6: Typical Graffiti at beam ends (Span 1, Girder 16 shown)

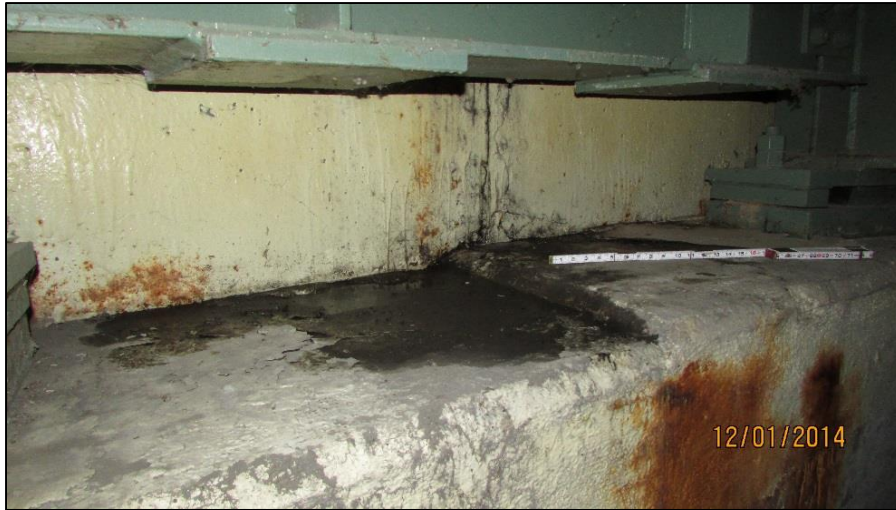
Photo 7: Water ponding on beam seat (Span 3, North Abutment, Bay 4)

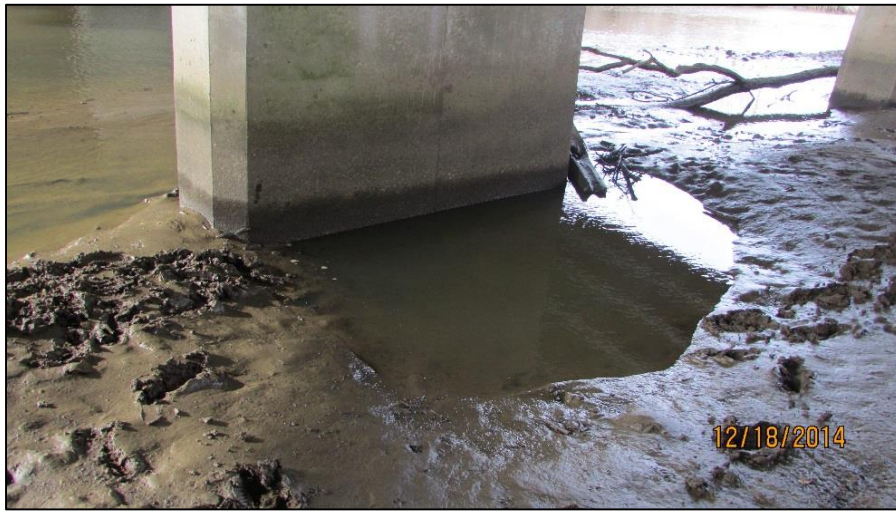
The substructure exhibits map cracking throughout the repaired areas, but the concrete appears to be sound (see Photo 8). There are widespread delaminated areas in the concrete at the beam seat of both abutments. Water is ponding on the beam seats from the leaking expansion joints above at both abutments. Many of the previous repair patches on the piers are map cracked, but most of the patches are sound with only a few delaminated areas present. At the south face of Pier 2, Bearing 4 is partially undermined by a 6" deep spall at that location (see Photo 10). There are some vertical cracks present in the piers and abutments, up to 1/8" wide. These cracks are not widespread. Scour holes were observed at the north face of the base of all three pier columns that make up Pier 2 (see Photo 11). These holes extended the full face of the pier column, up to 10' wide, and 2' deep.

Photo 11: Typical scour at Pier 2 (Span 3, Center pier column)

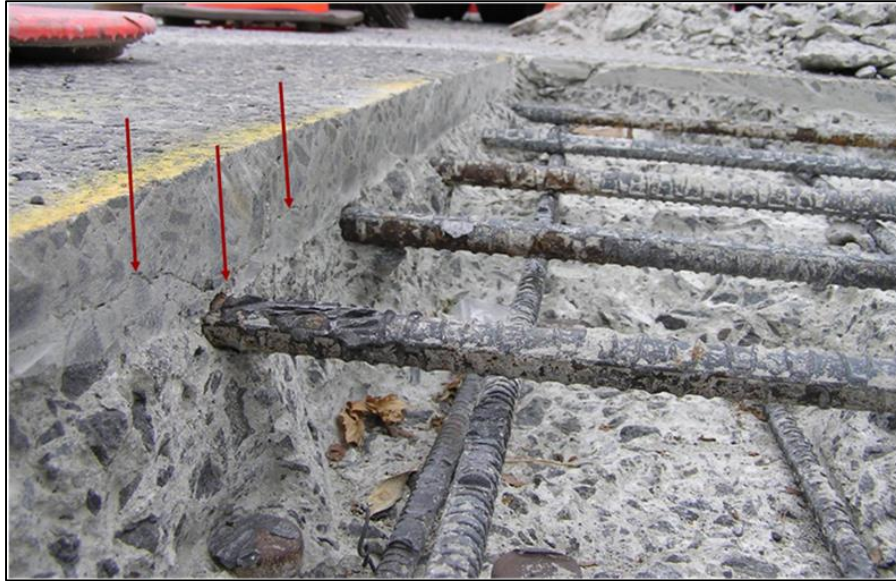
Based on experience with cores taken while conducting similar NDE surveys, observed delaminations in the structural deck are typically encountered at the top level of steel reinforcement. The delamination level is not constant, but is a curved surface of a variable depth, often arching from one reinforcement bar to another (See *Photo 5.1*).

Photo 5.1: Typical delamination in structural deck.

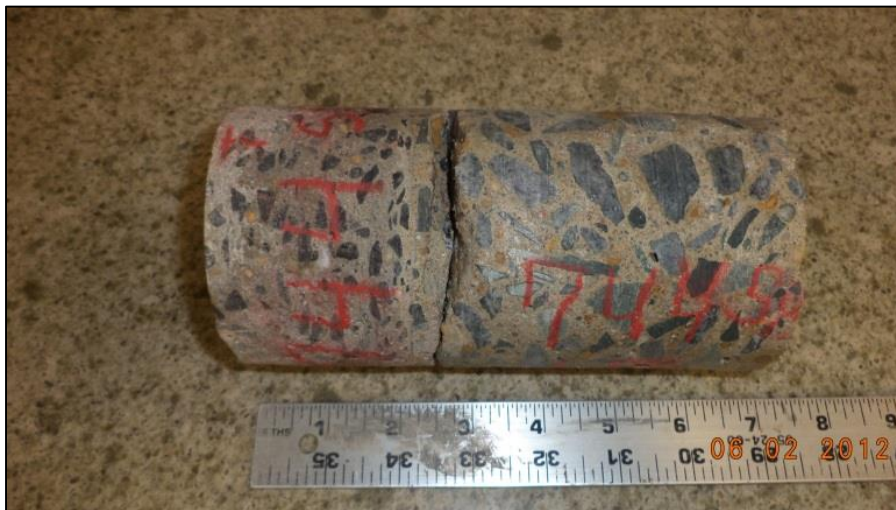
Concrete delamination at the level of reinforcement is consistent with the findings of the cores taken during this project. For example, Core 1-744 SB-1P was taken from Bridge 1-744 with a measured overlay thickness of $1\frac{1}{2}$ " and the structural cover of $1\frac{1}{2}$ ". The location of the crack in the core is at approximately 3" below the top of the overlay (See Photo 5.2), coinciding with the location of reinforcement. Although the depth is variable, for the purpose of quantifying the proposed repair, it is assumed that the depth of repair will extend 1" beyond the bottom mat of steel reinforcement. To account for repairs that may extend below the depth of reinforcement, 10% of the delaminations are assumed to require a repair depth greater than $3\frac{1}{2}$ ", but less than a full-depth repair. Full-depth repairs are assumed to be required only where indicated by inspection field observations identified as spalling in the soffit.

Photo 5.2: Delamination in concrete core at approximate level of steel reinforcement
(Bridge 1-744, Core 744SB-1P)
